CHARACTERISTICS OF UNREINFORCED MASONRY BUILDINGS IN ANTAKYA THROUGH FIELD SURVEY

ABSTRACT:

KEYWORDS: Unreinforced masonry, field survey, performance score, seismic risk.

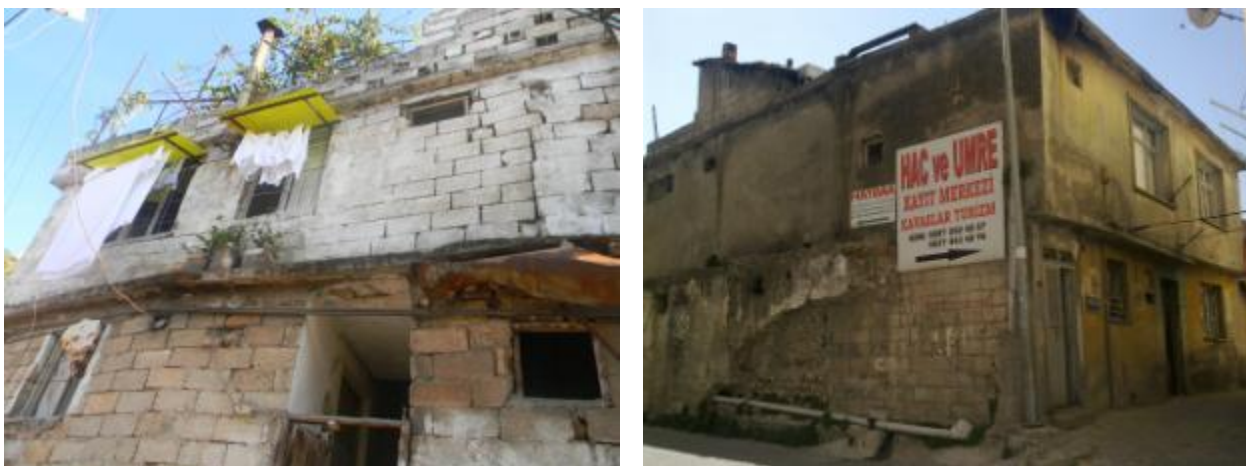
Figure 3. Surveyed masonry buildings constructed with cellular concrete blocks

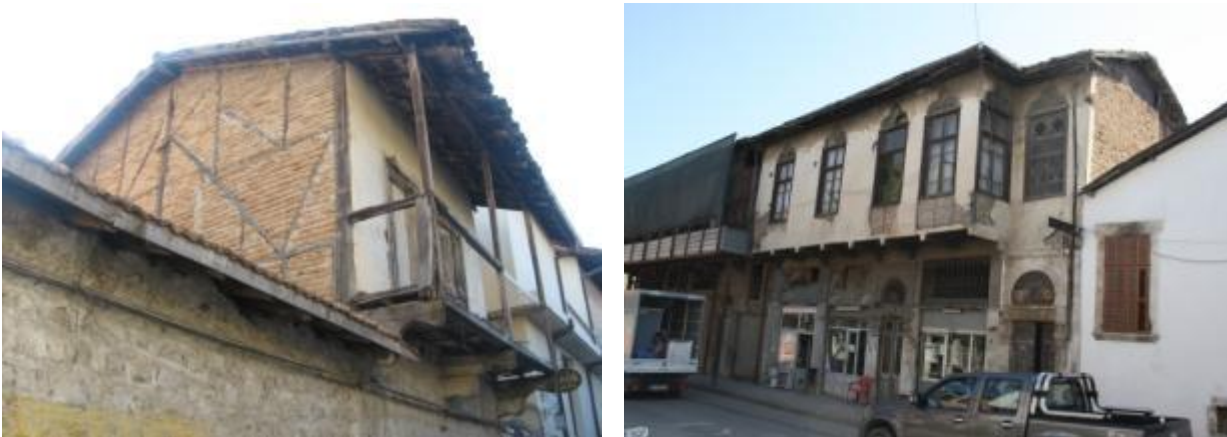
Within the rich and mixed socio-cultural fabric of the city, it is also worth mentioning the traditional buildings, which were considered in the context of “mixed” systems during the field survey. These buildings, generally constructed during the Ottoman Empire, have a rigid stone masonry ground floor and timber-laced brick (or adobe) masonry walls in the upper stories (Figure 5). This type of mixed traditional construction is called “hımış”. In order to assess the seismic performance of these buildings, one should consider the coupling of different materials and structural systems present within the same building.

Figure 5. Traditional timber-laced masonry buildings called as “hımış”

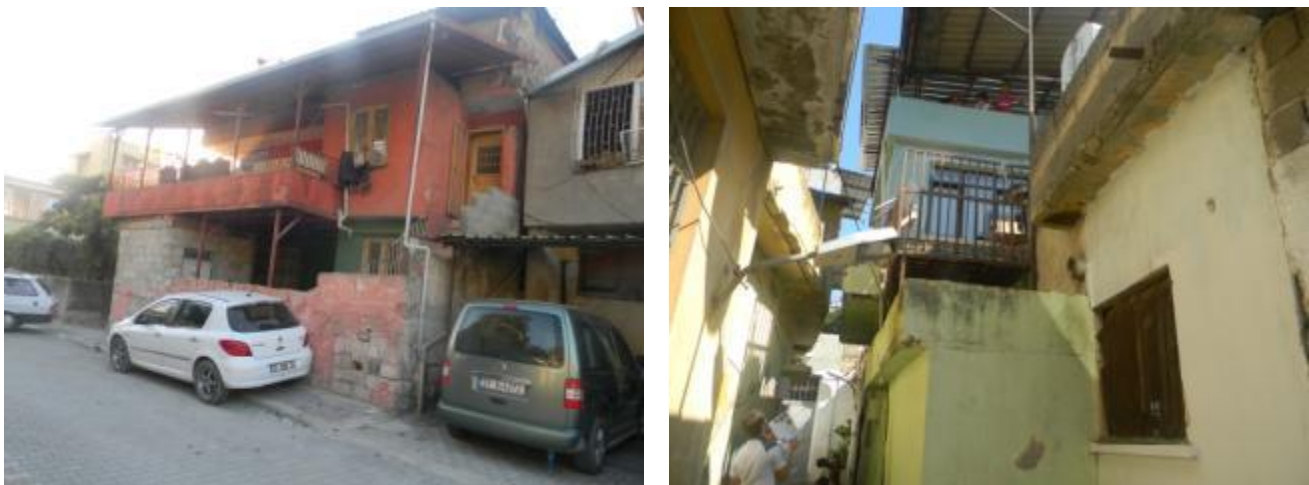
In terms of elevation geometry, the surveyed buildings are again classified as regular and irregular. Irregularity in elevation refers to misalignment of openings with height, heavy overhangs, set-backs and penthouses (Figure 7). The statistical data in Figure 6.b is limited to buildings with two or more stories for which the elevation geometry becomes relevant and it reveals that irregularity in elevation is an important issue for masonry buildings in Antakya.

Figure 7. Surveyed masonry buildings with irregularities in elevation

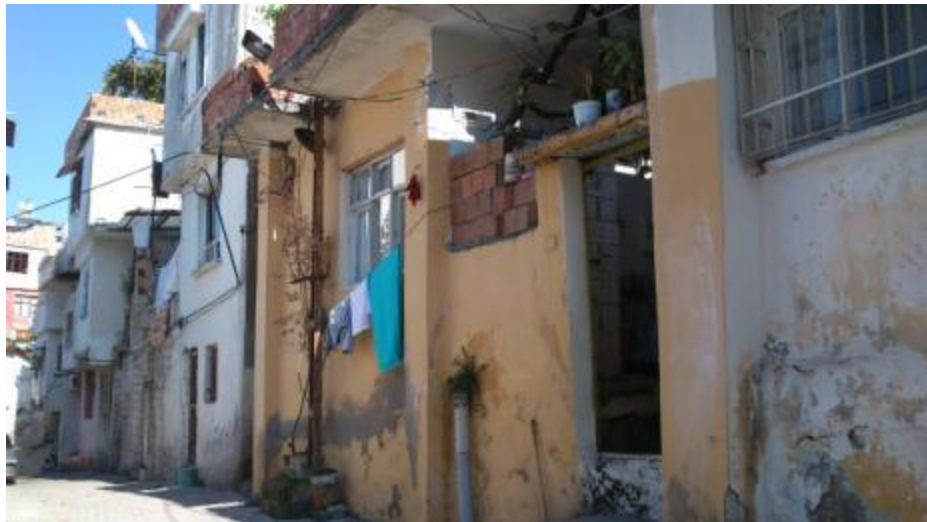
According to Figure 8.a, most of the surveyed buildings seem to be located in clusters adjacent to each other (see Figure 9). It can be misleading to consider the seismic performance of these buildings individually due to pounding effects and aggregate (block) behavior due to coupling as also stated by Abrahamczyk *et al.* (2012). Especially the buildings at the corner of the block can suffer more from the coupled block motion.

Figure 9. Clusters of surveyed masonry buildings
