CHARACTERISTICS OF UNREINFORCED MASONRY BUILDINGS IN ANTAKYA THROUGH FIELD SURVEY

ABSTRACT:

KEYWORDS: Unreinforced masonry, field survey, performance score, seismic risk.

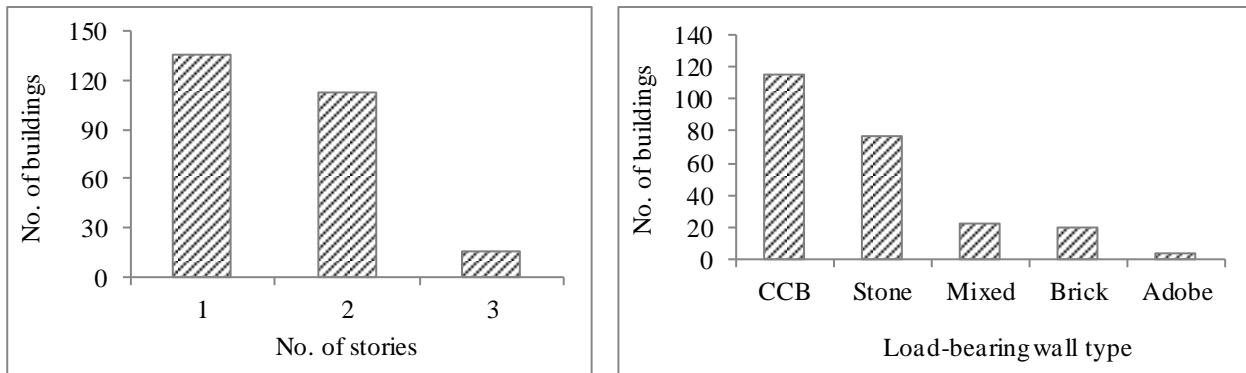
Antakya is an Anatolian town possessing several physical and social traces from different periods and civilizations as a result of continuous settlement since ancient times (Naycı *et al.*, 2003). As suggested by Topçu and Kubay (2012), the city can be divided into two districts as “new city” and “old city”. The new city refers to the newly developing and planned district on the west side of Asi river whereas the old city denotes the historical district that has an organic urban fabric on the east side of the river. Most of the surveyed masonry buildings are within the old city. According to the statistical data, majority of the surveyed buildings are either one or two stories (Figure 2.a). It is also observed that the most commonly used load-bearing wall materials are cellular concrete block (CCB) and stone (Figure 2.b). According to the current Turkish earthquake code (2007), such concrete blocks with holes should not be used as load-bearing wall material since they have very low strength, but unfortunately this is not the case in practice. Hence concrete masonry buildings (Figure 3) are generally vulnerable to seismic action. On the other hand, most of the stone masonry buildings in the region are rather old. They can be classified as “simple stone masonry” in which irregularly sized and rounded stones had been used with either lime or mud mortar in the load-bearing wall construction. In some of these buildings, large connecting stones had been used in the corners to maintain the integrity of the perpendicular walls (Figure 4.a). There are also buildings that can be classified as “massive stone masonry” (Figure 4.b).

Figure 2. Statistical distribution of a) number of stories, b) load-bearing wall type

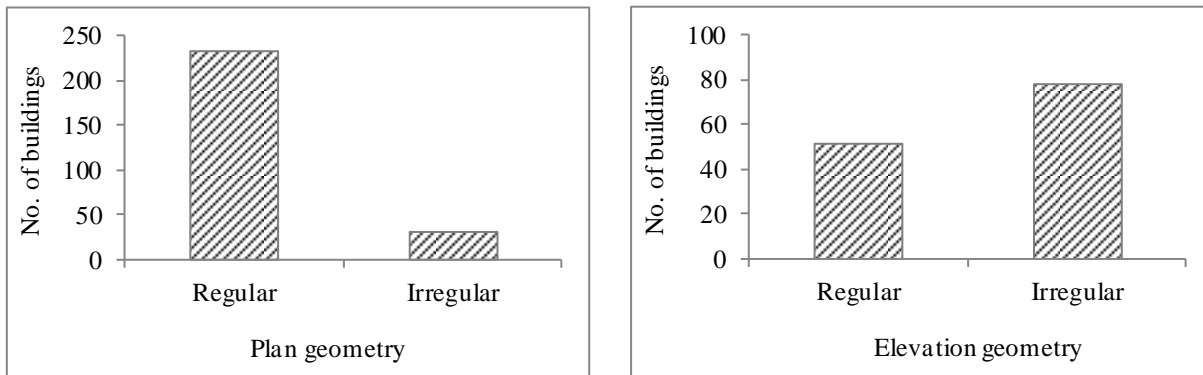
The statistical distributions of surveyed masonry buildings in terms of geometry in plan and elevation are provided in Figure 6. In this study, regular buildings in plan are considered as the ones that have rectangular floor plans or nearly rectangular floor plans with small projections whereas irregular buildings in plan are defined as the ones that possess irregular (L-shaped, U-shaped, or of any other type) floor plans, plans with non-parallel axes or both. The results indicate that a significant percent of the surveyed buildings seems to be regular in plan (Figure 6.a). However it should be noted that most of the regular buildings are small-sized single story buildings.

In terms of elevation geometry, the surveyed buildings are again classified as regular and irregular. Irregularity in elevation refers to misalignment of openings with height, heavy overhangs, set-backs and penthouses (Figure 7). The statistical data in Figure 6.b is limited to buildings with two or more stories for which the elevation geometry becomes relevant and it reveals that irregularity in elevation is an important issue for masonry buildings in Antakya.

Figure 6. Statistical distribution of a) plan geometry, b) elevation geometry (for masonry buildings with two or more stories)

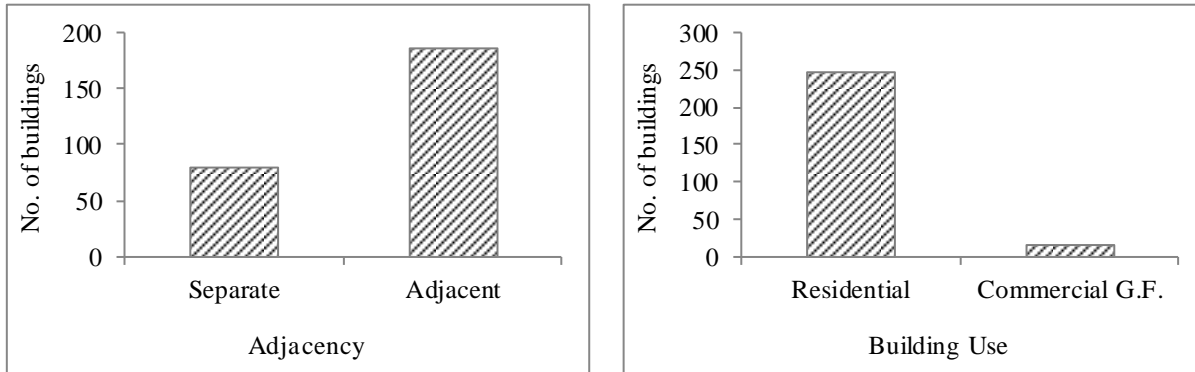
According to Figure 8.a, most of the surveyed buildings seem to be located in clusters adjacent to each other (see Figure 9). It can be misleading to consider the seismic performance of these buildings individually due to pounding effects and aggregate (block) behavior due to coupling as also stated by Abrahamczyk *et al.* (2012). Especially the buildings at the corner of the block can suffer more from the coupled block motion.

Figure 8.b reveals that most of the surveyed buildings are in residential use only. There are few buildings for which the ground story is used for commercial purposes but the upper stories are residential, which is denoted as “Commercial G.F.” in the figure.

Figure 8. Statistical distribution of a) adjacency, b) building use (occupancy)

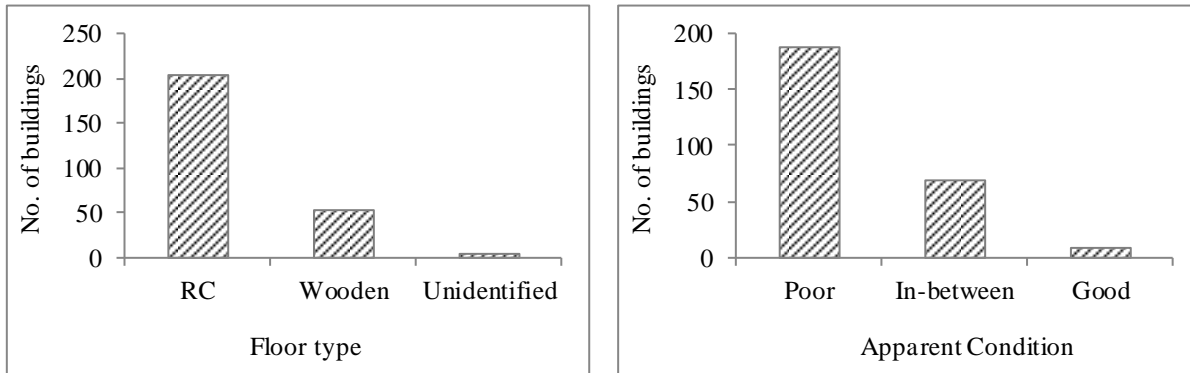
Another important parameter to assess the seismic behavior of masonry structures is the floor type. From Figure 10.a it can be clearly observed that most of the surveyed masonry buildings have rigid RC floors. The buildings with flexible wooden floors are generally the older constructions. There are few buildings for which the floor type had not been identified.

The last parameter to consider is the apparent condition of the surveyed building. As it can also be seen in the bottom line of the data collection form in Figure 1, the apparent condition of the surveyed buildings can be regarded as good, in-between (moderate) and poor, which is a subjective decision given by the surveyor. The material and construction quality, workmanship and existence of any type of damage (due to any reason) in the building guides the surveyor to make this classification regarding the apparent condition of the building. The statistics in Figure 10.b show that most of the buildings were considered as being in poor condition and there are only few to be considered as good. This is an important conclusion which is also linked to the socio-economic status of people living in these dwellings.

Figure 10. Statistical distribution of a) floor type, b) apparent condition

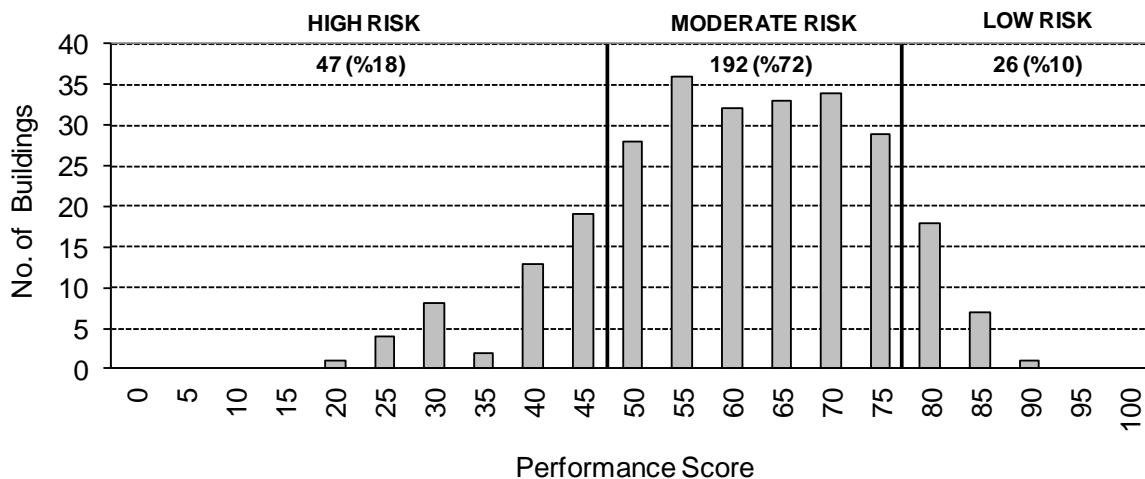
The aforementioned assessment method is applied to 265 masonry buildings surveyed in Antakya and the final performance scores (PS) are obtained. The distribution of the buildings according to their performance scores are shown in Figure 11. Theoretically, a masonry building with PS=100 can be regarded as an earthquake-resistant structure without any structural deficiency. On the other hand, a masonry building with PS=0 or having a very low PS value can be regarded as a highly vulnerable building against seismic action with many structural deficiencies. The PS values in between these two bounds give information about the relative seismic performance of a masonry building. Accordingly, Figure 11 reveals that most of the masonry buildings in Antakya have PS values between 45 to 80. In other words, these can be considered as buildings which possess some typical structural deficiencies.

Figure 11. Distribution of the masonry buildings in Antakya according to PS values

In accordance with the above evaluation, two limit states have been proposed for the performance score. This means there exist three performance states: low risk, moderate risk and high risk (see Figure 11). The average performance score and the related standard deviation for each performance state are also provided in Table 1. Using these values, it is assumed that buildings with $PS \leq 45$ are in “high risk” region, the ones with $45 < PS \leq 75$ are in “moderate risk” region and the ones with $PS > 75$ are in “low risk” region. Hence among 265 surveyed buildings in Antakya, 47 of them (18%) possess high seismic risk, 192 of them (72%) possess moderate seismic risk and 26 of them (10%) possess low seismic risk. The reason of having the majority of the buildings with moderate seismic risk is the similar construction practice due to socio-economical and cultural characteristics in the region in addition to the local and traditional techniques. It is common to encounter typical buildings with 1-2 stories, made of stone or concrete masonry units, poor material and construction quality, irregularities in plan and elevation. Although exceptional, it is also possible to encounter buildings with much more and less seismic performance in the region. Such buildings already reside at either end of the distribution shown in Figure 11.

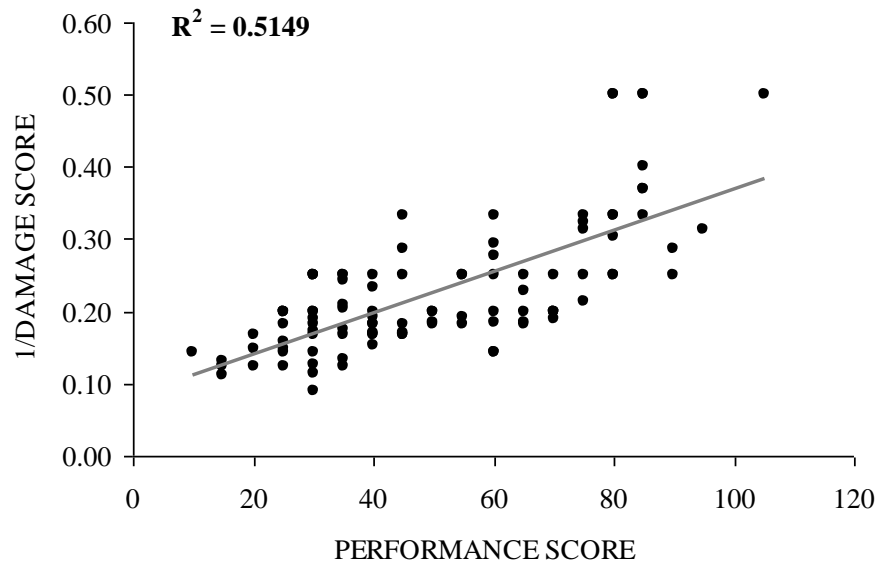
The Dinar database includes 102 masonry buildings, for which the damage levels were determined by using the damage assessment form of the Ministry of Public Works and Settlement (METU-EERC, 1996). According to this form, damage scores (DS) are awarded for the walls of the most damaged story of the masonry structure as well as for the stairs and roof. Damage is classified as undamaged (0–1), minor (1–3), moderate (4–6), severe (7–9) or collapse (>9). The numbers in parenthesis represent the score range for each damage state. The comparison of the inverse of the damage score (1/DS) with the performance score (PS) obtained by using the proposed methodology is presented in Figure 12. There seems to be an increasing trend line for the scattered data. In other words, buildings with serious damage after the earthquake receive low PS values as it should be the case. R^2 value is not too high since the damage score obtained after the earthquake does not contain many of the parameters used in calculating the performance score by the proposed methodology, so it is not possible to make a one-to-one comparison between these two measures.

Figure 12. Comparison of performance score (PS) with the inverse of the damage score (1/DS) obtained after the 1995 Dinar earthquake
